Property Repairs

May 10 2012

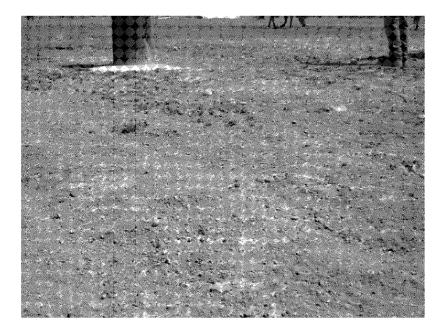
Disturbed/compacted soil by drilling equipment near well head

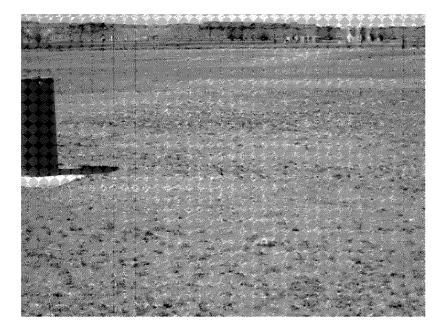
Disturbed area looking west

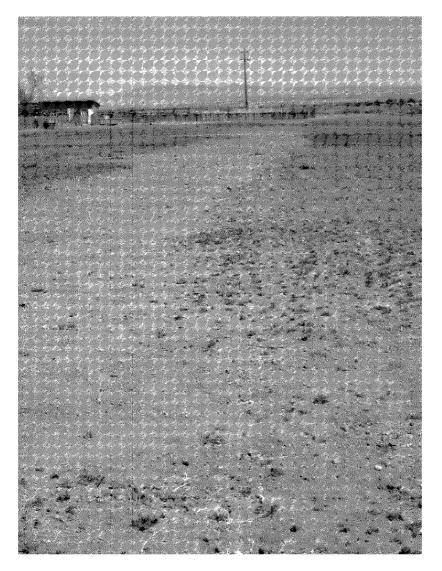
Disturbed area looking north
